“Equipment & Vehicle Interaction”

(Are we gambling with the Risk?)

Mr Cres Bulger (Author & Presenter)

Department of Natural Resources and Mines

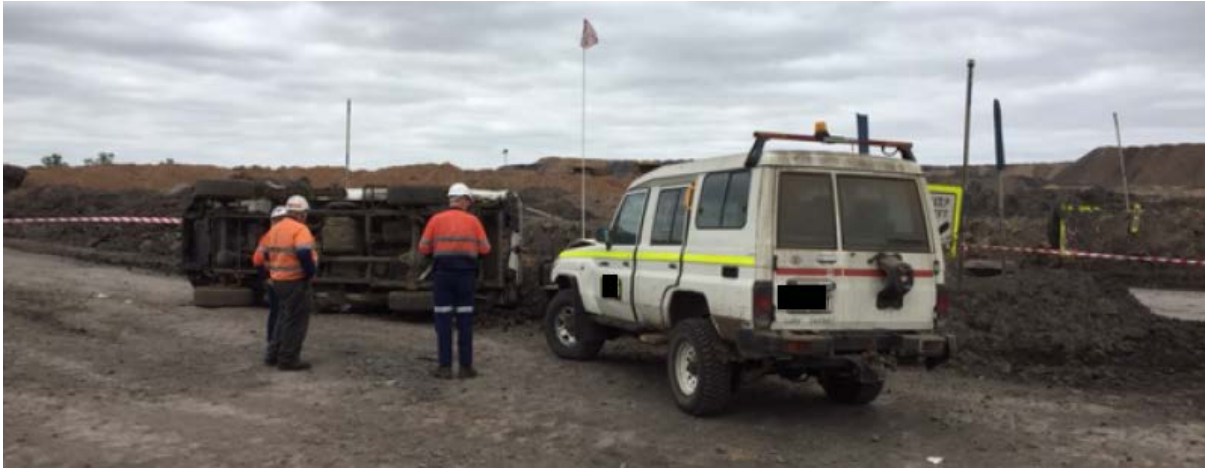
Incident 1. Two Toyota troop carriers collided at an intersection in the hours of darkness, and one vehicle ended up rolling over. There were seven occupants in the two vehicles, and luckily no one was injured as there was certainly the potential for serious injuries to occur. A poorly designed intersection was one of the main causal factors in this event as the centre bunds on the approaches to the intersection were so high the drivers of the light vehicles couldn't see over them.

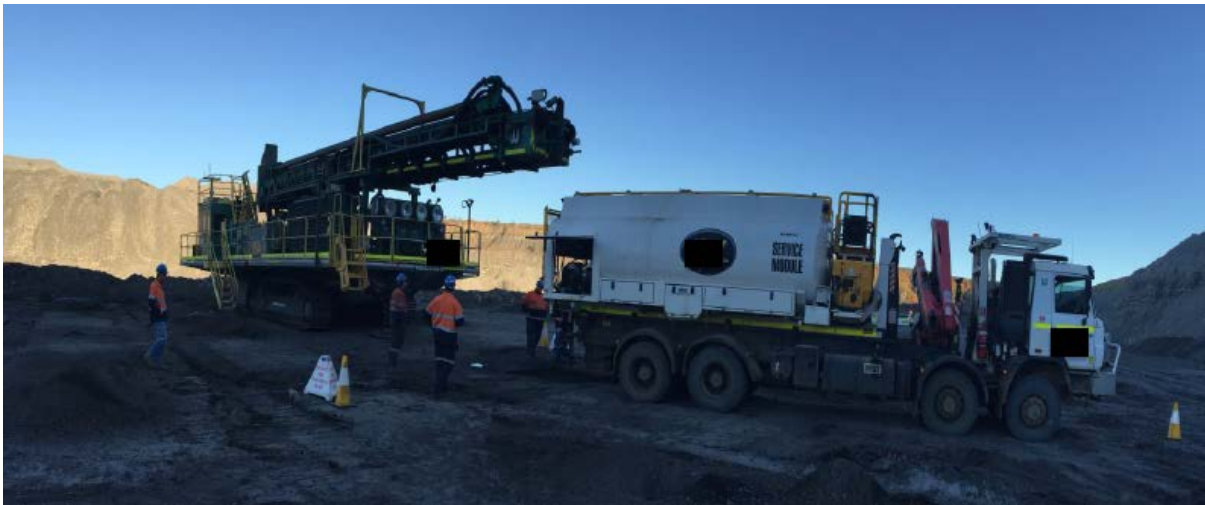
Incident 2. An overburden drill trammed into a service truck that had parked at the end of the drill to refuel it. The serviceman was on the ground at the time, and managed to get out of the way after seeing signs that drill was going to move. Numerous procedures were breached in the incident (isolation, communications, mine traffic rules and servicing). This may seem like an innocuous event to many, and it was recognised at recent Open Cut Mine Manager's seminars conducted in Central Queensland that there is a lot of current middle and senior management in open cut coal mines that have little knowledge of previous serious accidents where people have been fatally injured as a result of being caught between pieces of mobile equipment. And therefore these people have little understanding of why certain sections of legislation apply to us today. In fact three people have lost their life in Bowen Basin open cut coal mines since July 1988 as a result of being caught between pieces of mobile equipment.

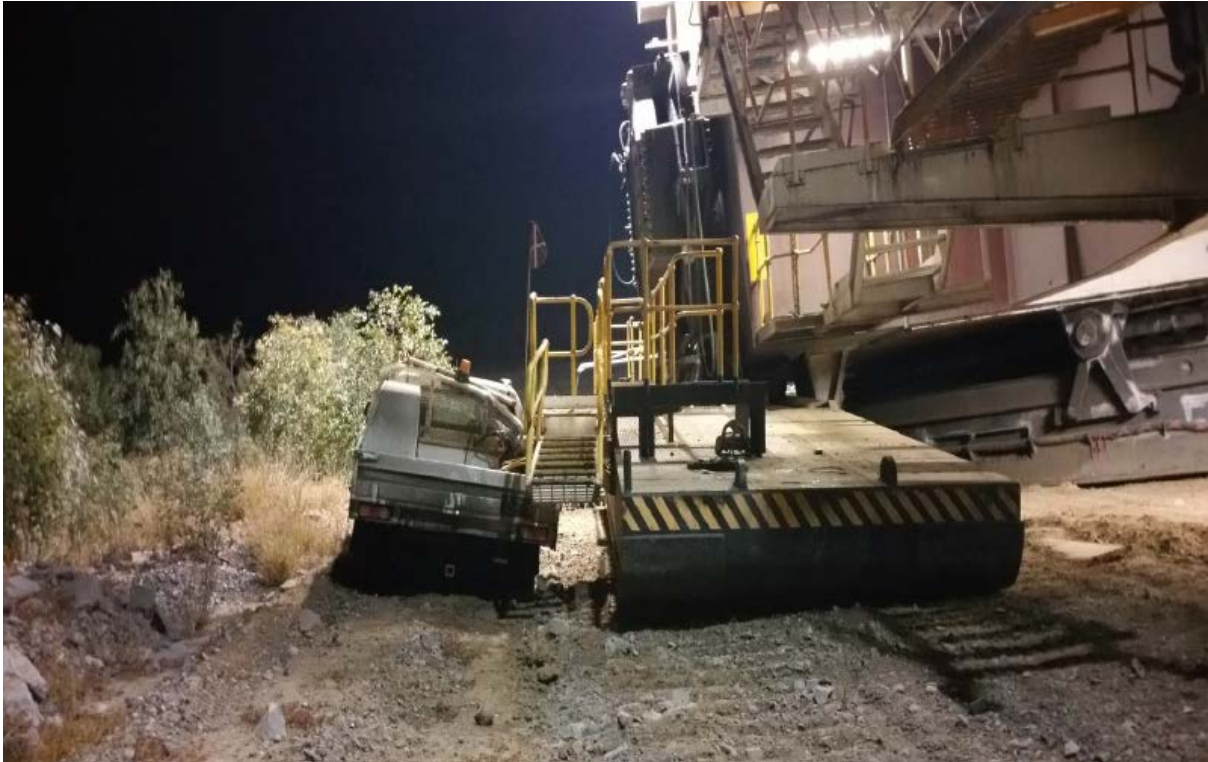
Incident 3. A dragline engaged propel and collided with a light vehicle that had one person inside it, and this event occurred during the hours of darkness. Just imagine if the dragline had of engaged swing instead of propel? The result would have been much different as the structural integrity of the light vehicle would never withstand the impact of a dragline. Once again numerous procedures were breached (mine traffic rules, communications, operating the dragline, reporting hazards).

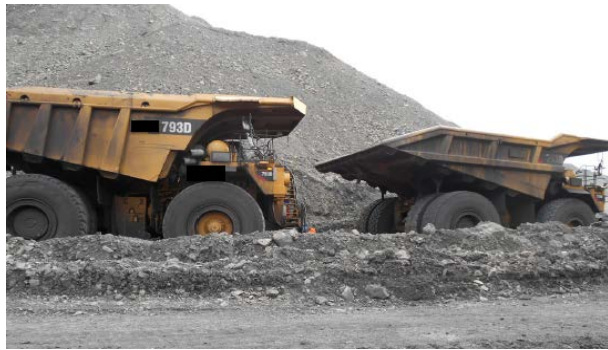
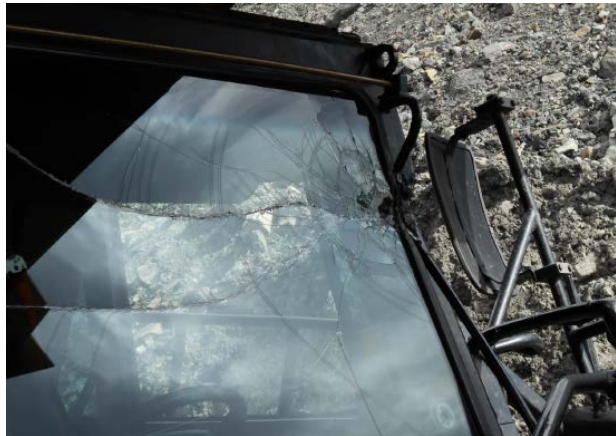
Incident 6. A large Cat rear dump truck has run into the rear of another large Cat rear dump truck that had parked on a down ramp awaiting the digging unit to relocate. Again the event occurred in the hours of darkness, and the second truck had almost braked to a stop when the contact was made. In the second picture its worth judging the distance between the rear tyres on the front truck and the front tyres on the second truck, and comparing that to the distance between the rear of the first truck's tray and the back of the second truck's cabin. This really shows if the collision occurred at any speed there is nothing preventing the cabin of the second truck from being completely destroyed.
