“Equipment & Vehicle Interaction”

(Are we gambling with the Risk?)

Mr Cres Bulger (Author & Presenter)

Department of Natural Resources and Mines

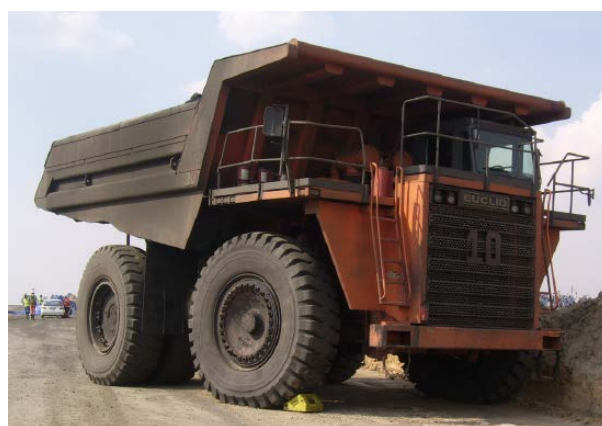
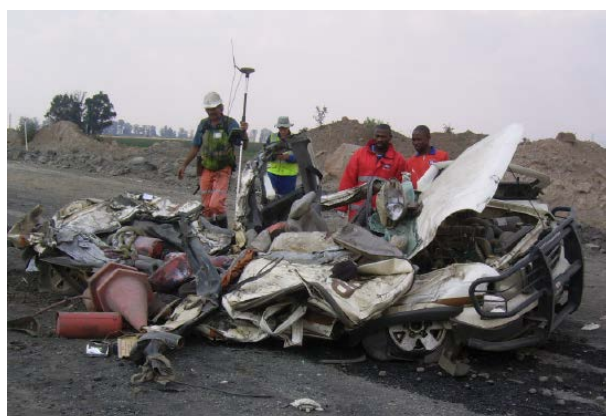
This incident is a sobering reminder for open cut coal mines in Qld. It occurred in October 2006 at Kleinkopje Mine in South Africa. A dual cab light vehicle was travelling along a haulroad with a large Euclid rear dump truck following it, when the light vehicle stopped (believed to be because of dust coming from another truck travelling in the opposite direction) and the following rear dump truck run over the light vehicle. Three of the four occupants in the light vehicle were fatally injured, and the fourth taken to hospital in a very serious condition. We need to ask ourselves, “could this kind of accident occur at our mine, and what controls do we have preventing it from happening”?
